Rod. dom, Nové Mesto, horná izba hnedá

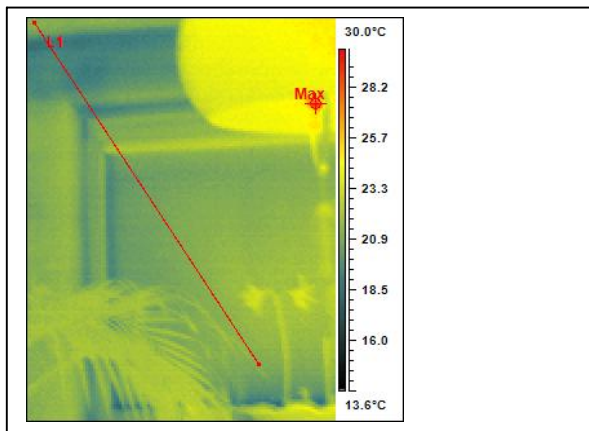
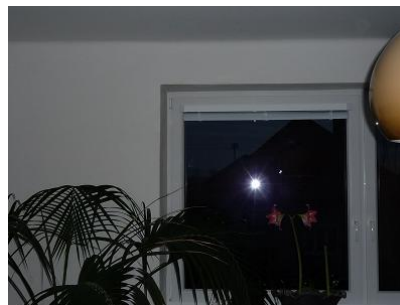
Infrared Image

Visual Image

Súbor	IMAGE050
Čas vytvorenia	Saturday, January 24, 2009 3:43:06 PM
Emissivity	0.98
Background Temp	26.7°C
Vzdialenosť	2.5m
Max Temp	30.9°C
Min Temp	17.3°C
Voice Comment

Object Parameter	Value
Max	30.9°C
L1:AvgTemp	21.0°C
L1:MaxTemp	22.2°C
L1:MinTemp	17.8°C

Comments: tepelné mosty : nadokenný preklad a veniec kritická povrchová teplota, možný vznik plesní. Riešenie: exteriérová tepelná izolácia, interierová tepelná izolácia Thermal-tec.
